ProxDot	
Rev A (Shipped)	
10/04/03	Monty Goodson

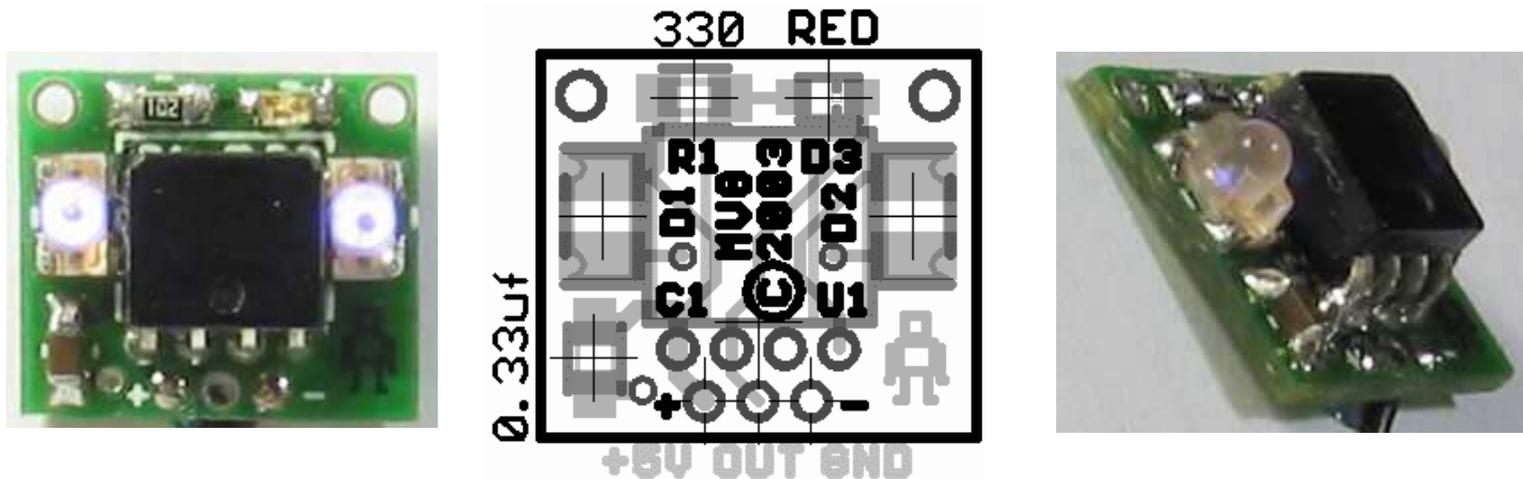
- 1.) Install all SMD components, except the IR LEDs (D1&D2.) Be sure to orient the indicator LED (D3) correctly. Look carefully at the top side (glass side) of the LED -- you should see the little square LED chip towards one end of the package. A magnifying glass helps here! The LED chip should line up with the short silkscreen lines between the pads for D3 on the board. In other words, the end of the LED with the chip goes towards the right.

- 3.) Install the IR LED's
 - a. Note that gold pads on the IR LEDs wrap up one side of the part, where there are little bays cut into the sides (as shown in the above layout picture). These need to face outward. The IR LEDs should be centered in the pad, and should not be placed farther towards the center of the board than the white silkscreen line between the IR LED pads.

- b. Test the IR LED's at this point, because once the heat-shrink is installed, you won't be able to easily replace them. The best way to test them is to use the diode-test function of a multi-meter: "+" to the left-most detector board pad (right below the "C1" silkscreen); "-" to the right-most detector board pad (right below the "U1" silkscreen.) There should be ~1.9-2.0V drop.
